Geotechnical Data Report Budge Drive Landslide Jackson, Wyoming

GEOTECHNICAL DATA REPORT
BUDGE DRIVE LANDSLIDE
JACKSON, WYOMING

JULY 3, 2014

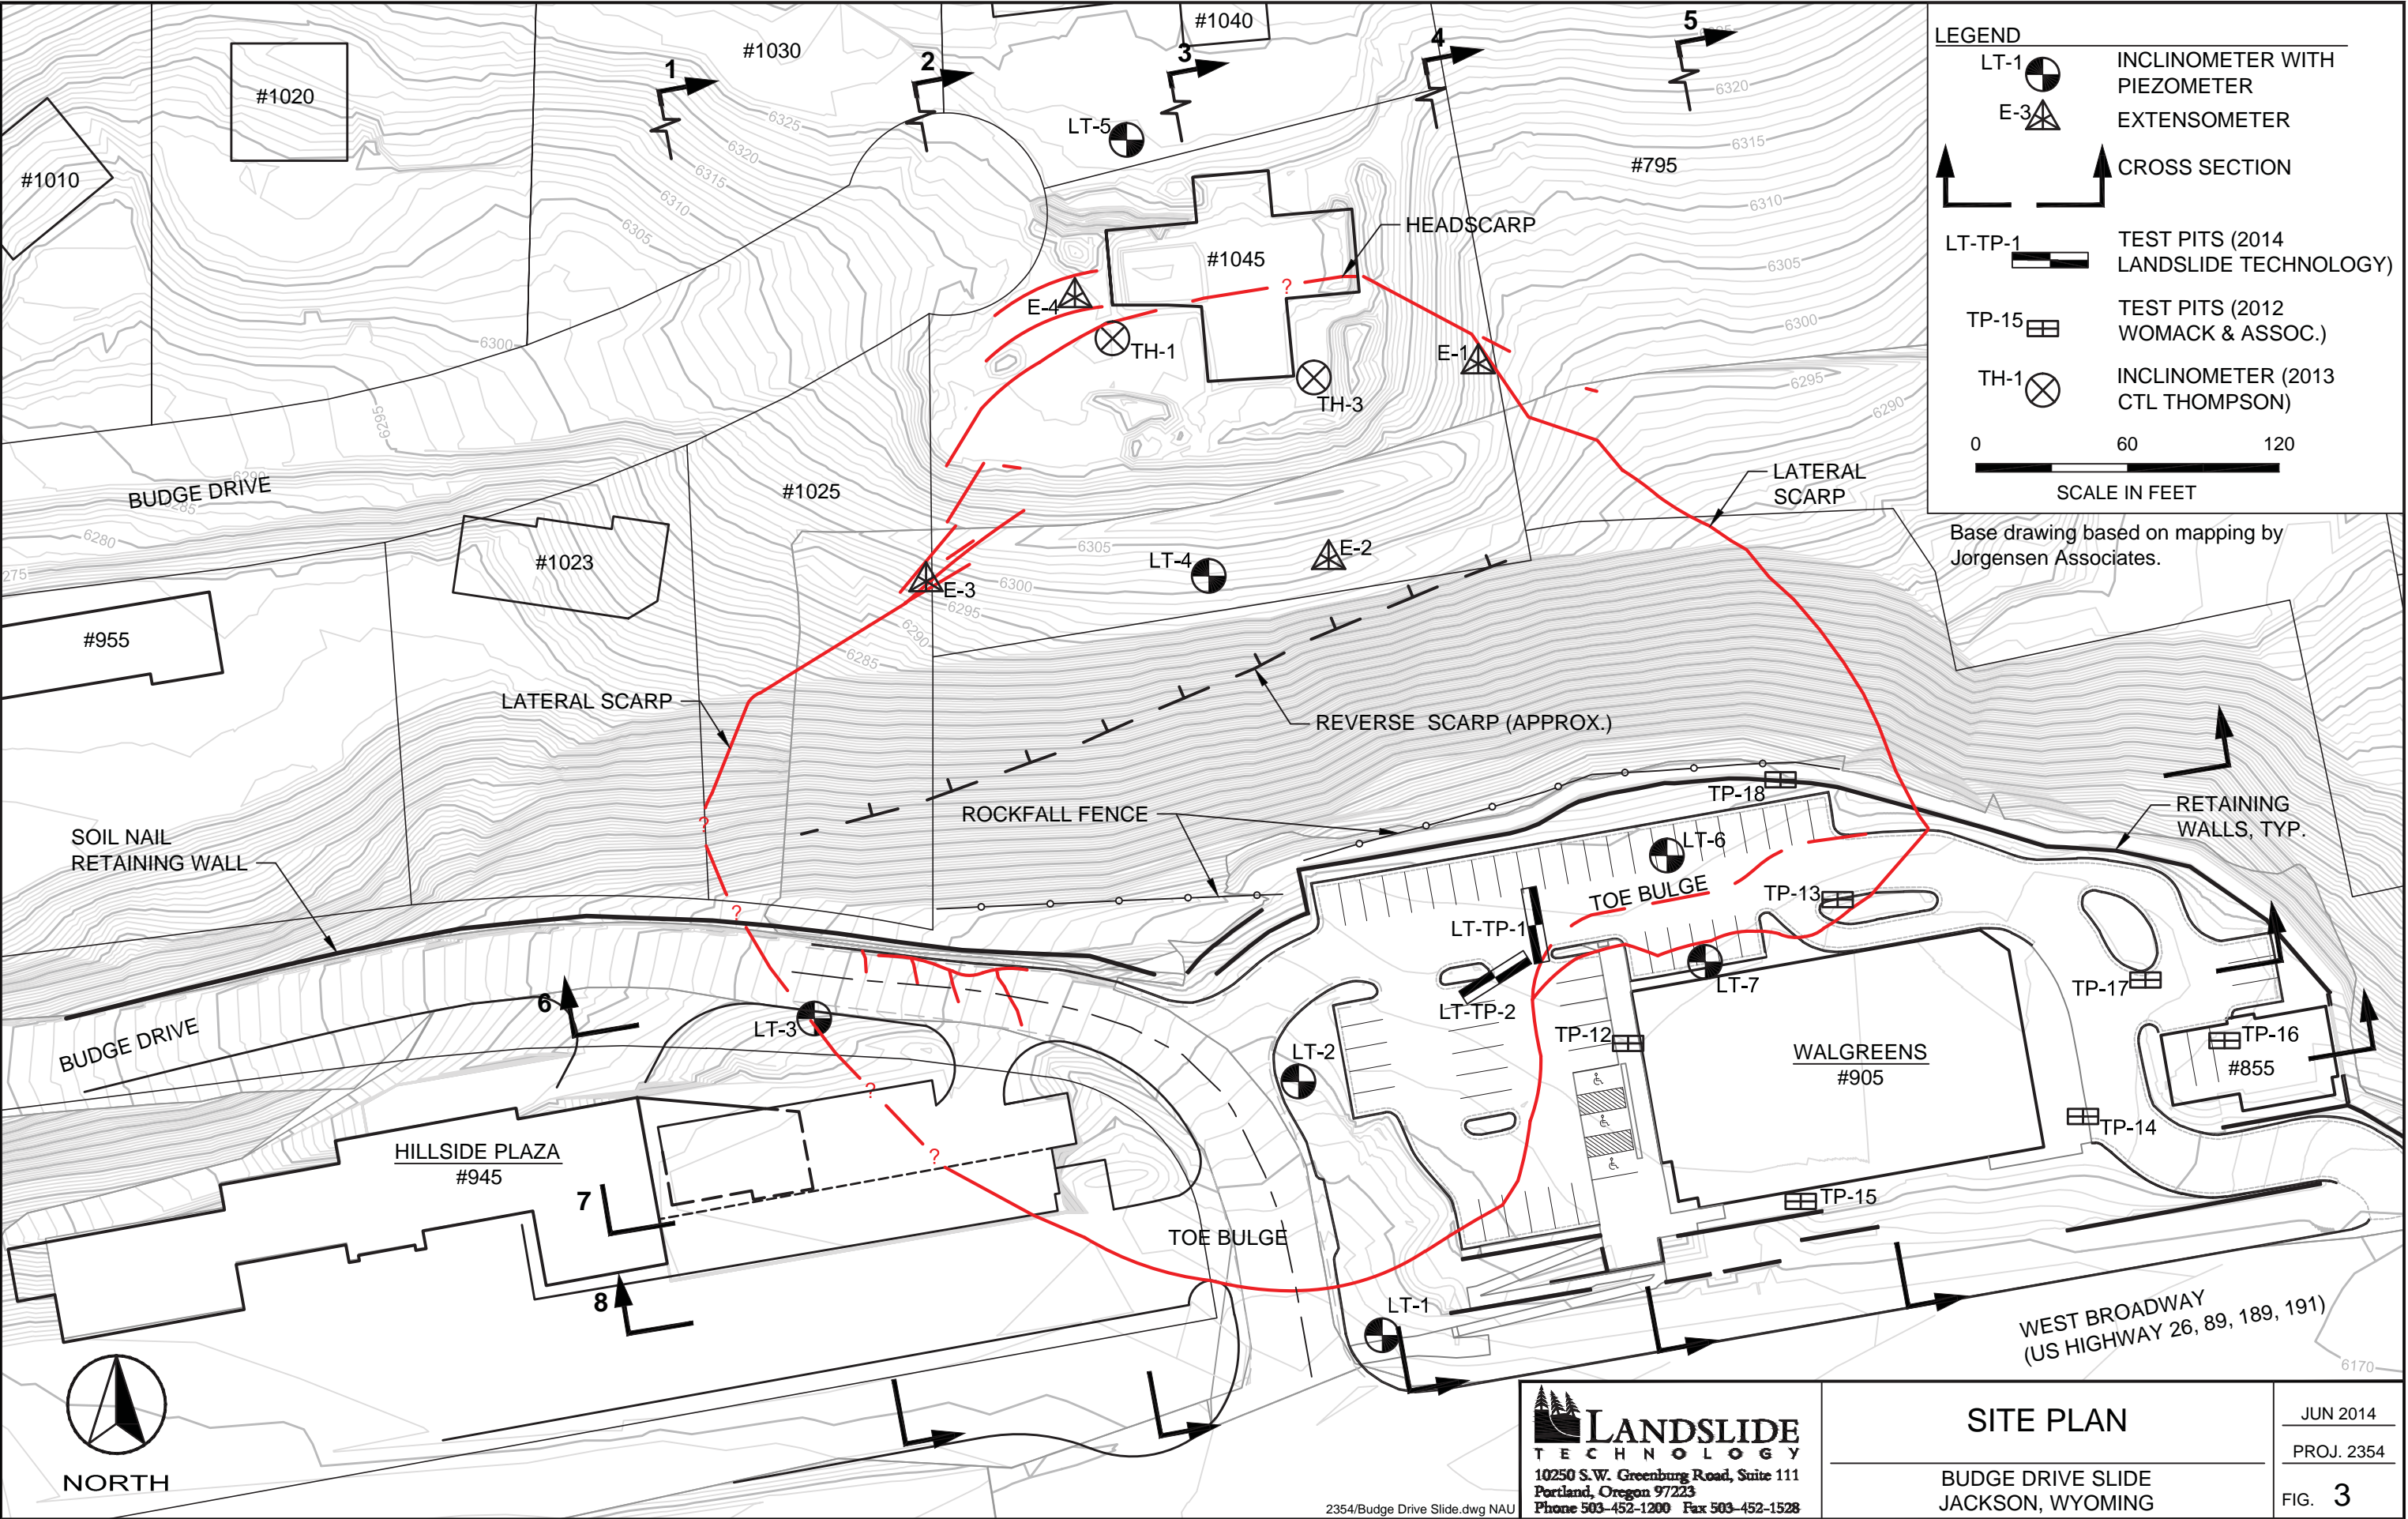
Initial mapping of landslide cracks, bulges and displacement of pavement and curbs was surveyed by Jorgensen Associates of Jackson, Wyoming. The initial Landslide Technology reconnaissance on April 10, 2014 included the observation of ground cracks, bulges and displacement of pavement and curbs to evaluate the extent of the landslide and to interpret slide mechanisms. The reconnaissance included the areas immediately adjacent to the boundary of active landslide features. Subsequent reconnaissances were performed to observe the progression of landslide movement and its effects (April 11 through May 9, 2014). The significant landslide features are shown on the Site Plan, Figure 3, the Landslide Photo, Figure 4, and various photos in Appendix B.

Lateral scarps along the east and west boundaries of the landslide expanded. A reverse scarp formed approximately 70 to 140 feet from the headscarp, indicating the presence of a graben. The reverse scarp developed about midslope of the quarry face near the westerly landslide limits and progressed upwards towards the center of the landslide to the top of the old quarry cut face (shown approximately on Figures 3 and 4).

Geologic units encountered at the slide site, listed from youngest to oldest, include the following: fill, colluvium, loess, landslide debris, alluvium and lacustrine deposits, weak sedimentary rocks, conglomerate, and basaltic andesite. Subsurface material conditions may be different than those exposed on the ground surface, and therefore are described in separate subsections of this report. A brief discussion of each geologic unit is given below. The subsurface conditions and landslide geometry are represented on a series of geologic cross-sections (Figures 6 through 13). The locations of the geologic cross-sections are shown on the Site Plan, Figure 3.
